LIGHTNING EFFECTS RELATING TO AIRCRAFT
PART I - LIGHTNING EFFECTS ON AND ELECTROMAGNETIC
SHIELDING PROPERTIES OF BORON AND GRAPHITE
REINFORCED COMPOSITE MATERIALS

F.A. Fisher
High Voltage Laboratory
General Electric Company

Technical Report AFAL-TR-72-5

January 1972

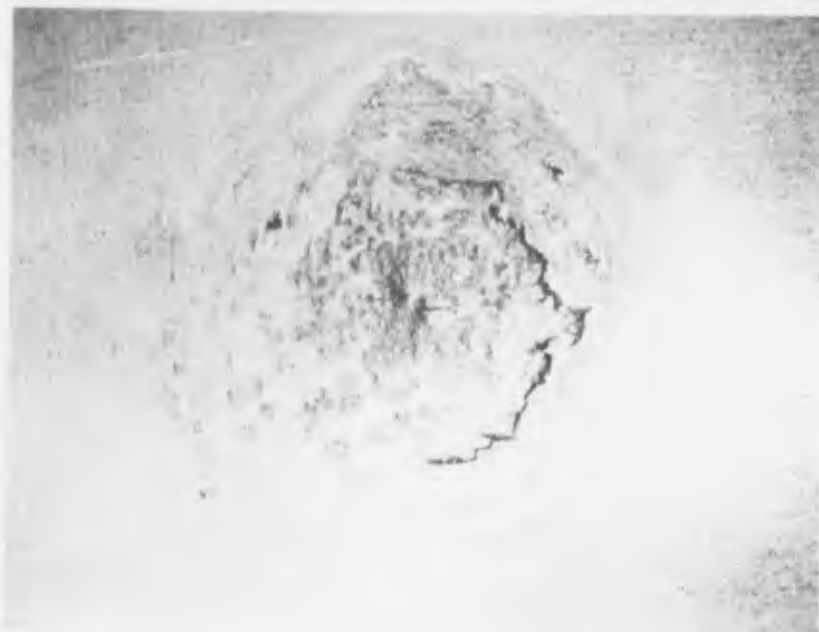
3X Enlargement of Burn at Arc Attachment Point

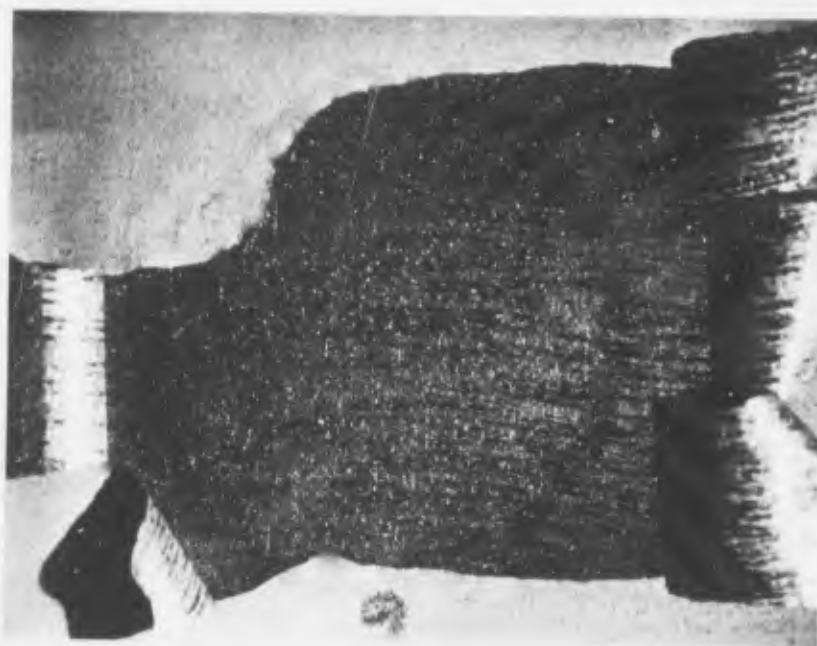
3X Enlargement of Peeled Nickel Coating

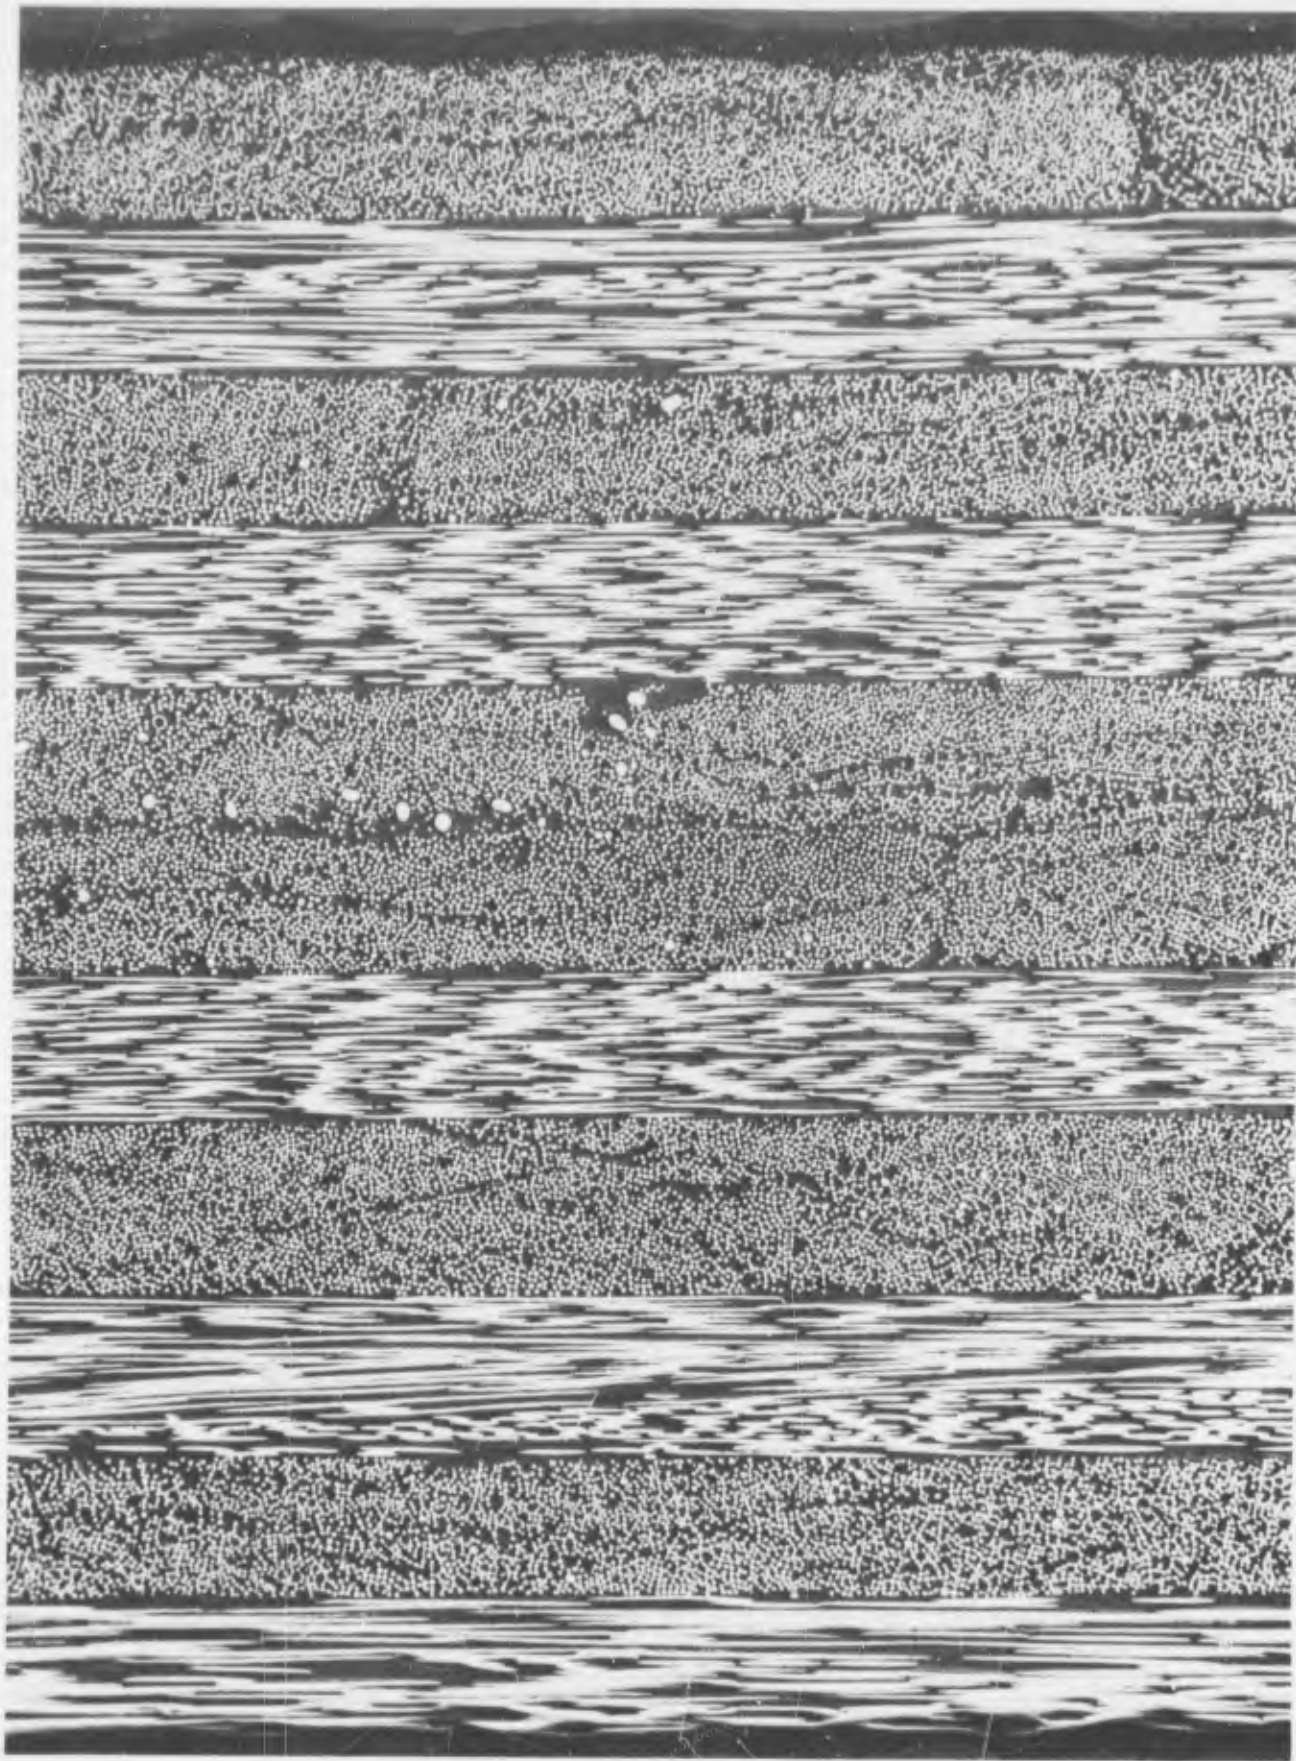
FIGURE 25 - 80X Photomicrograph of Panel GD-LS-70-1G. No Delamination Cracks
(Panel Front is at Bottom)

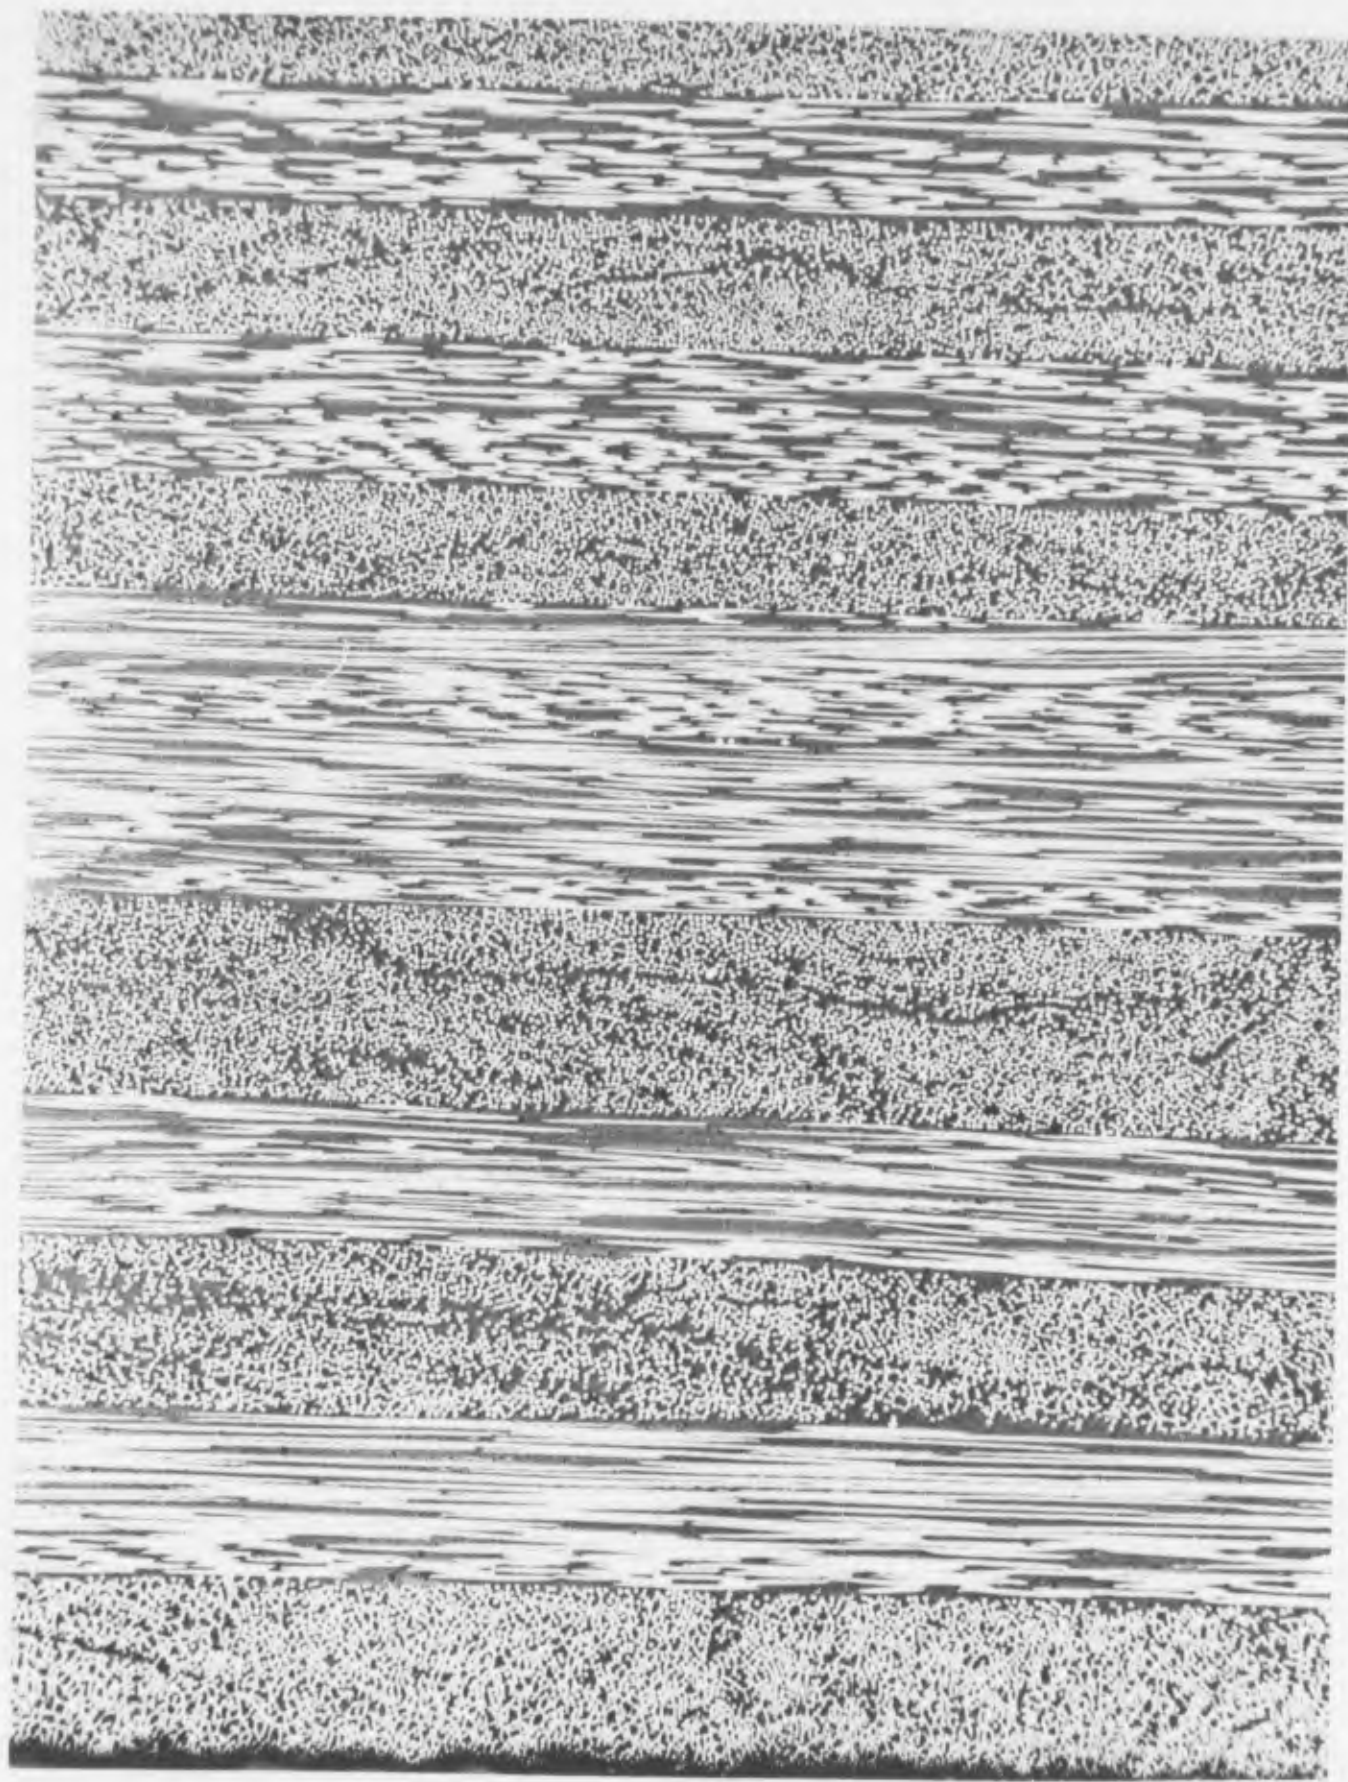
FIGURE 26 - 80X Photomicrograph of Panel GD-LS-70-2G. No Delamination Cracks
(Panel Front is at Bottom)

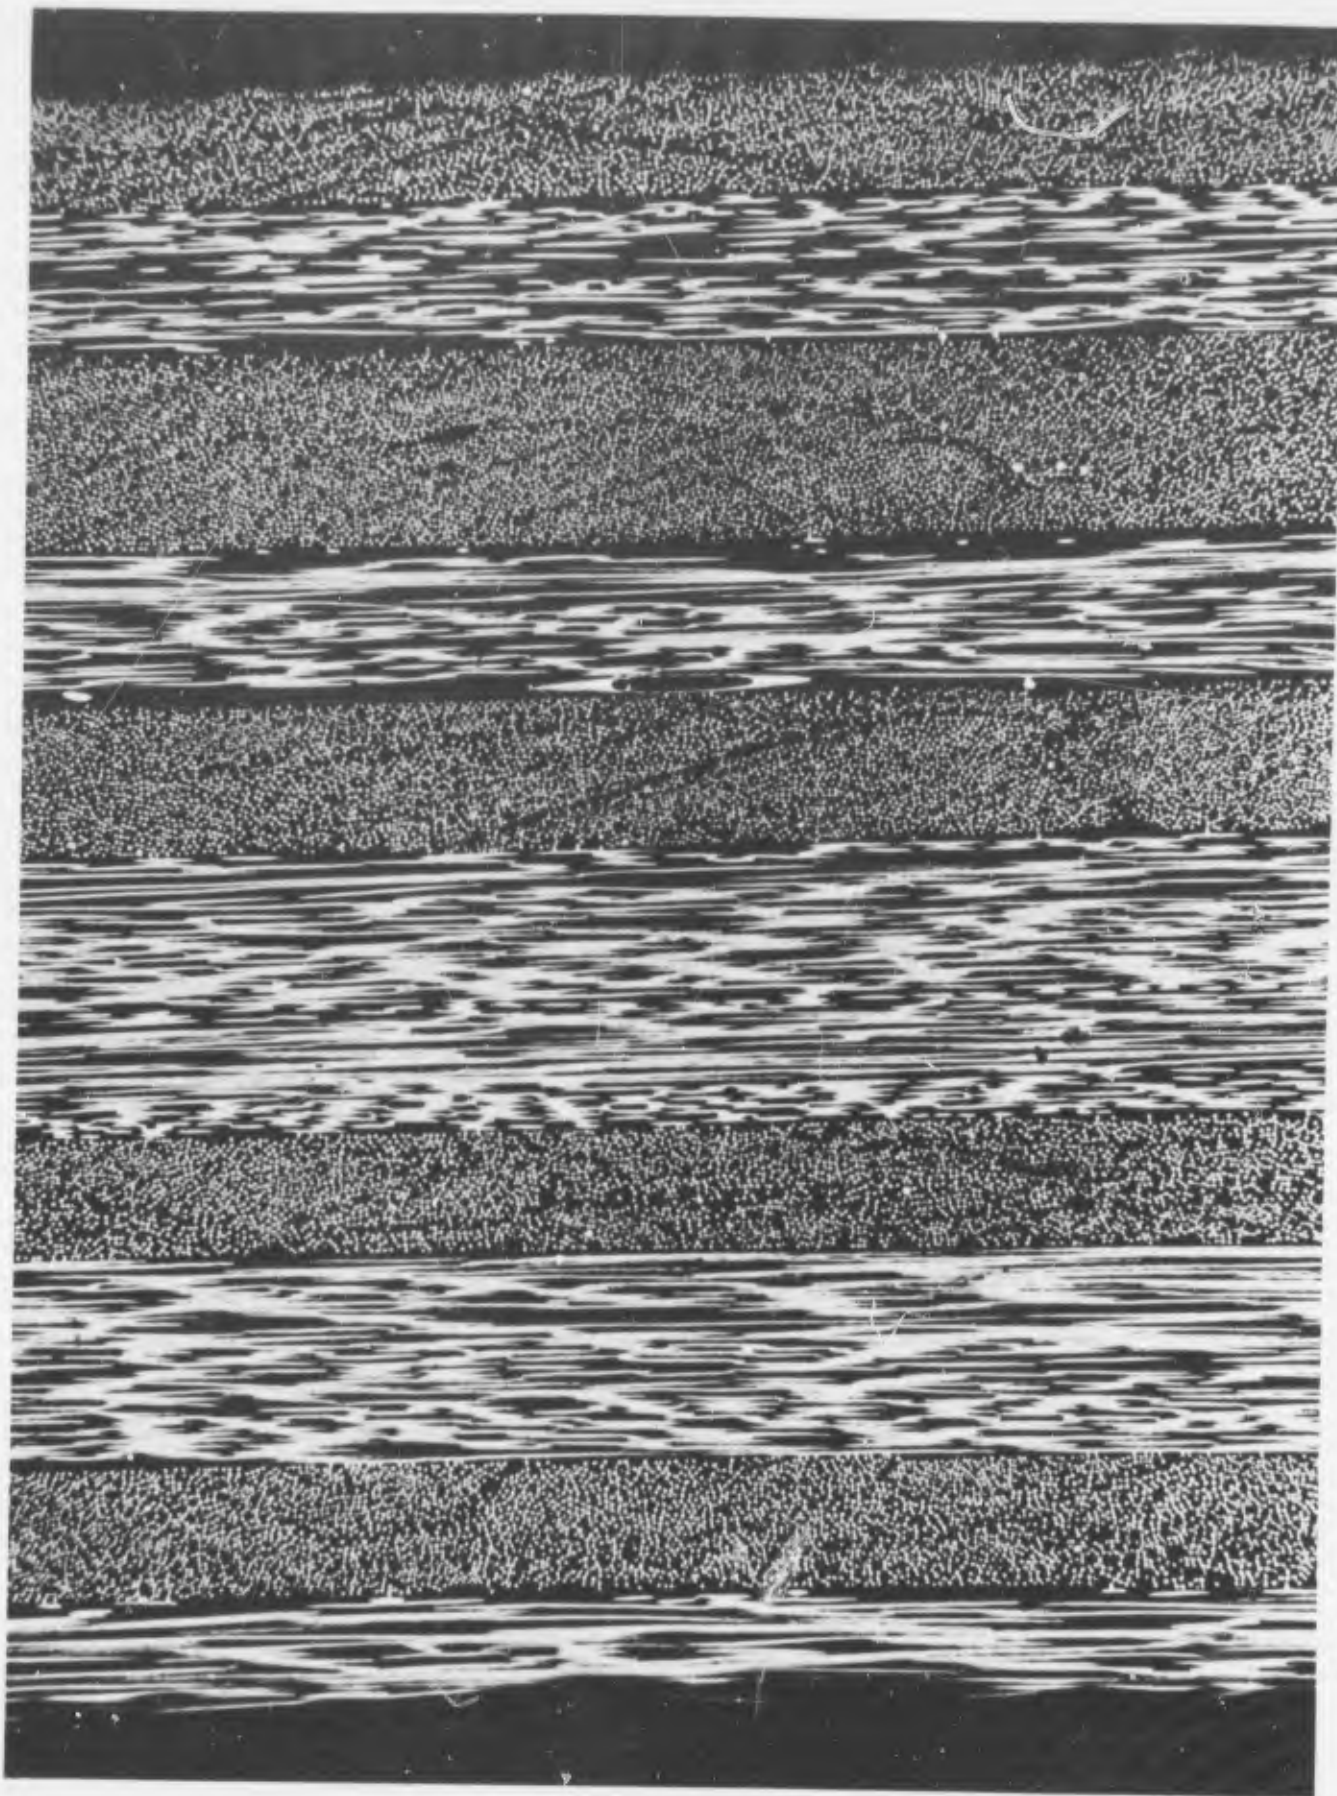
FIGURE 27 - 80X Photomicrograph of Panel GD-LS-70-3G. No Delamination Cracks
(Panel Front is at Bottom)

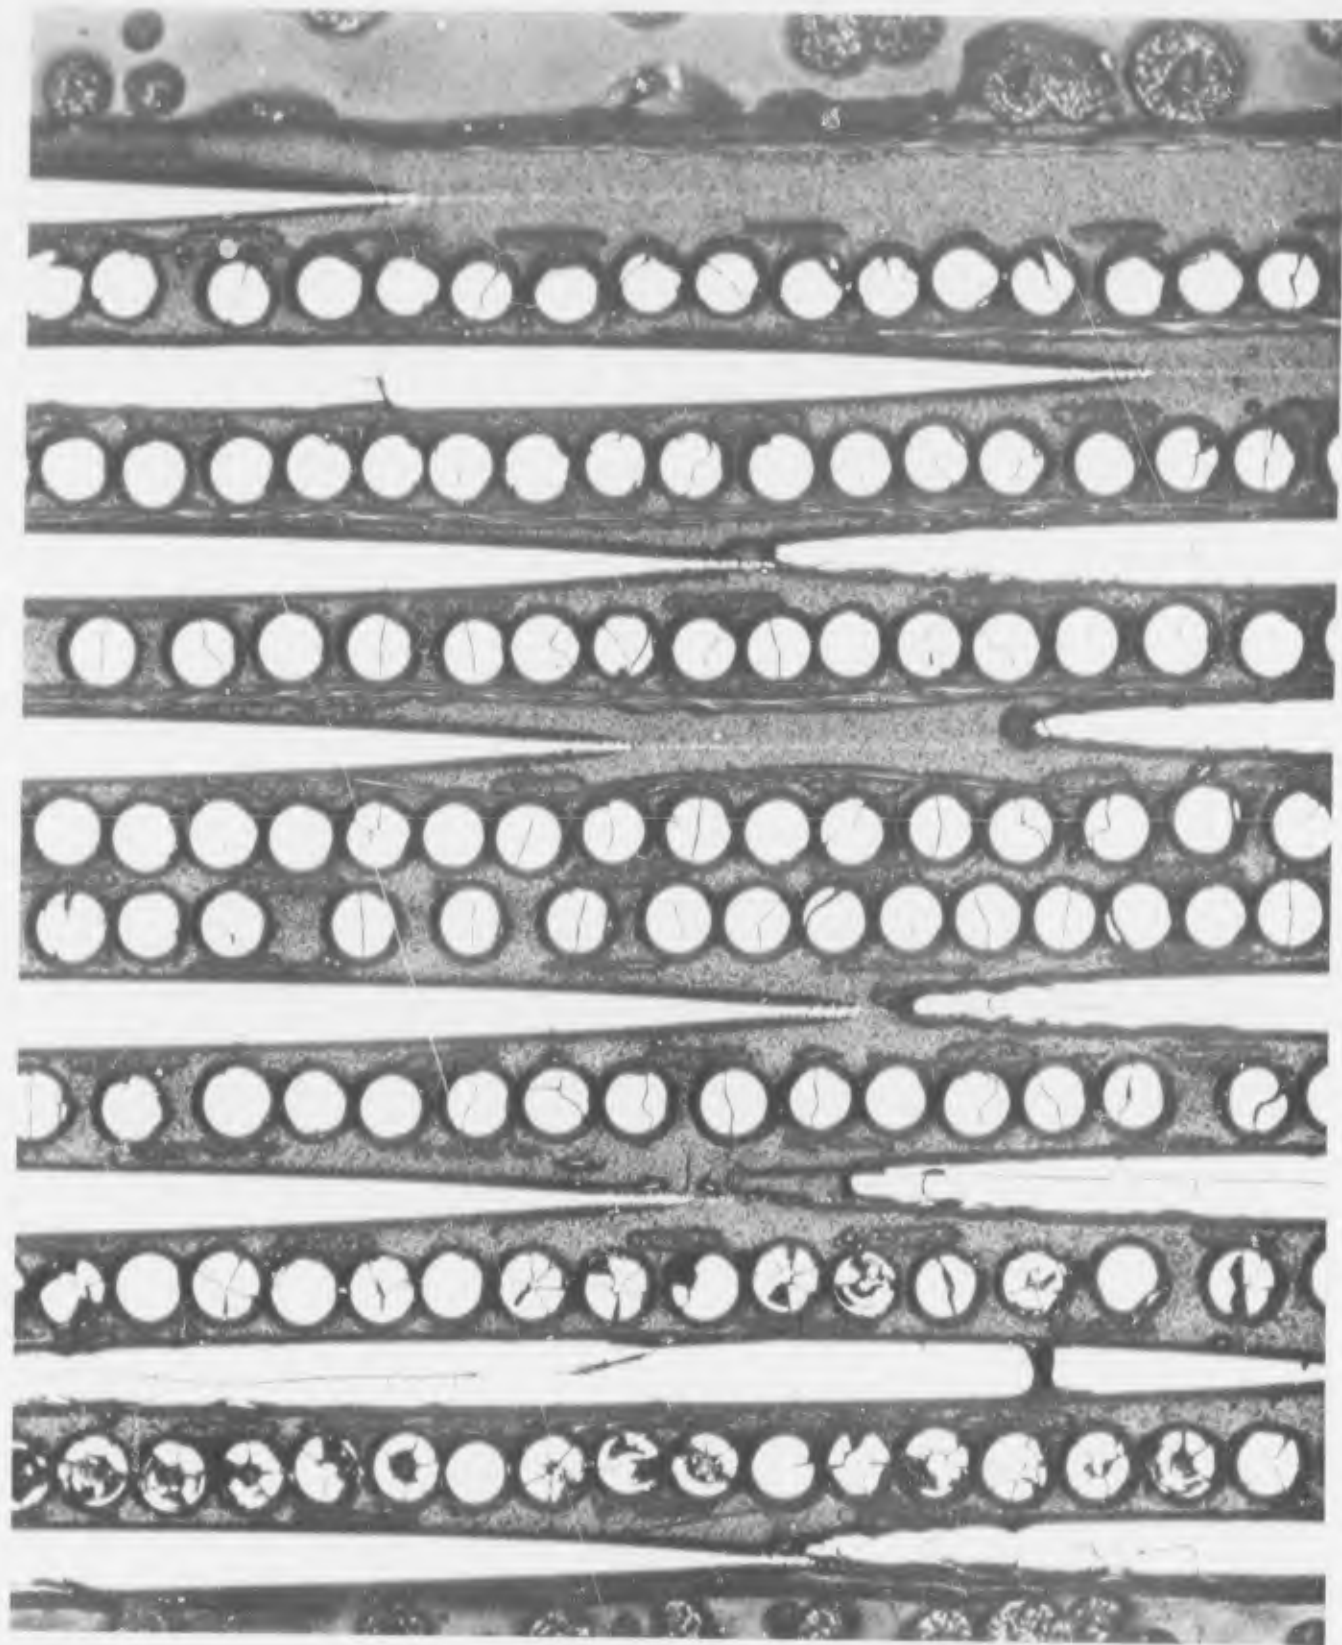
GD-LS-70-1B
(56 kA)

Photomicrographs of the boron samples are shown on Figures 45 through 48 and show some extremely interesting patterns. On these photomicrographs the front face of the panel again appears at the bottom of the figure. On sample GD-LS-70-1B only the bottom (on the photomicrograph), or surface rows of fiber are damaged. Cracks on other filaments are polishing cracks. The typical starshape cracking on the bottom filaments has been observed in other programs and occurs at a current density of about 10^5 amperes per square centimeter. This photograph thus provides some evidence that the current was confined, partially at least, to the plies next to the stricken face. The photomicrographs of panels GD-LS-70-2B and -3B show damage on all of the vertical plies. The damage is less intense on panel -3B than on -2B, which agrees with the visual observations of the panel surface, the short beam shear test, and the resistance measurements. Panel GD-LS-70-4B shows severe damage on all plies. This series of photographs is an excellent example of the progressive increase in the degree of damage as the arc current is increased. Figure 48, which shows the vertical destruction of almost every filament, is typical of the melting of the W_2B_5 core by excessive current.

FIGURE 45 - 80X Photomicrograph of Tested Panel Showing Typical Star-Shaped Fractures of Boron Filaments at Bottom of Photo, First Two Rows Horizontal Fibers Undamaged. Panel Front at Bottom.

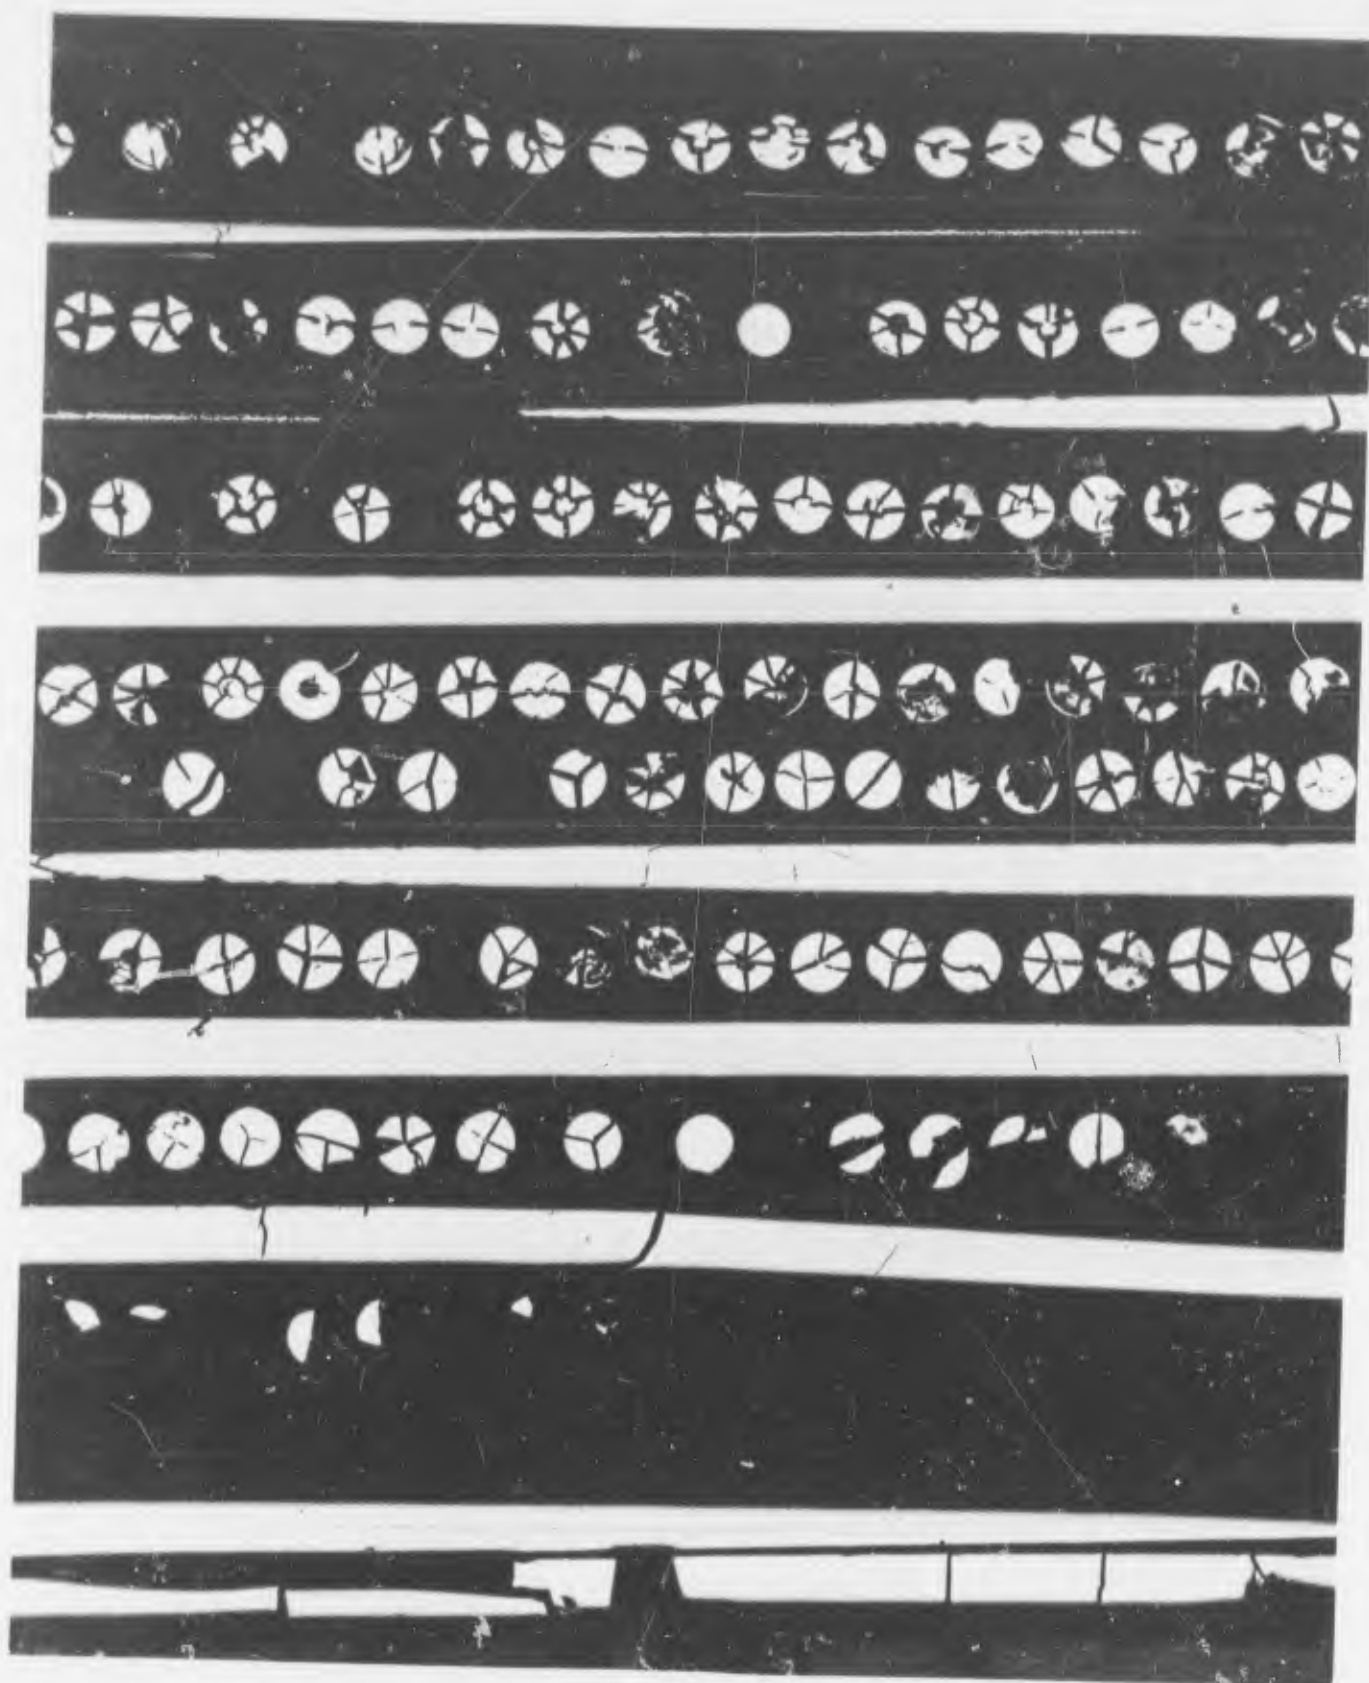
GD-LS-70-2B
(73 kA)

FIGURE 46 - 80X Photomicrograph of Tested Panel Showing Star-Shaped Damaged Filaments Dispersed. Note Beginning of Delamination at Bottom of Photograph. Panel Front at Bottom.

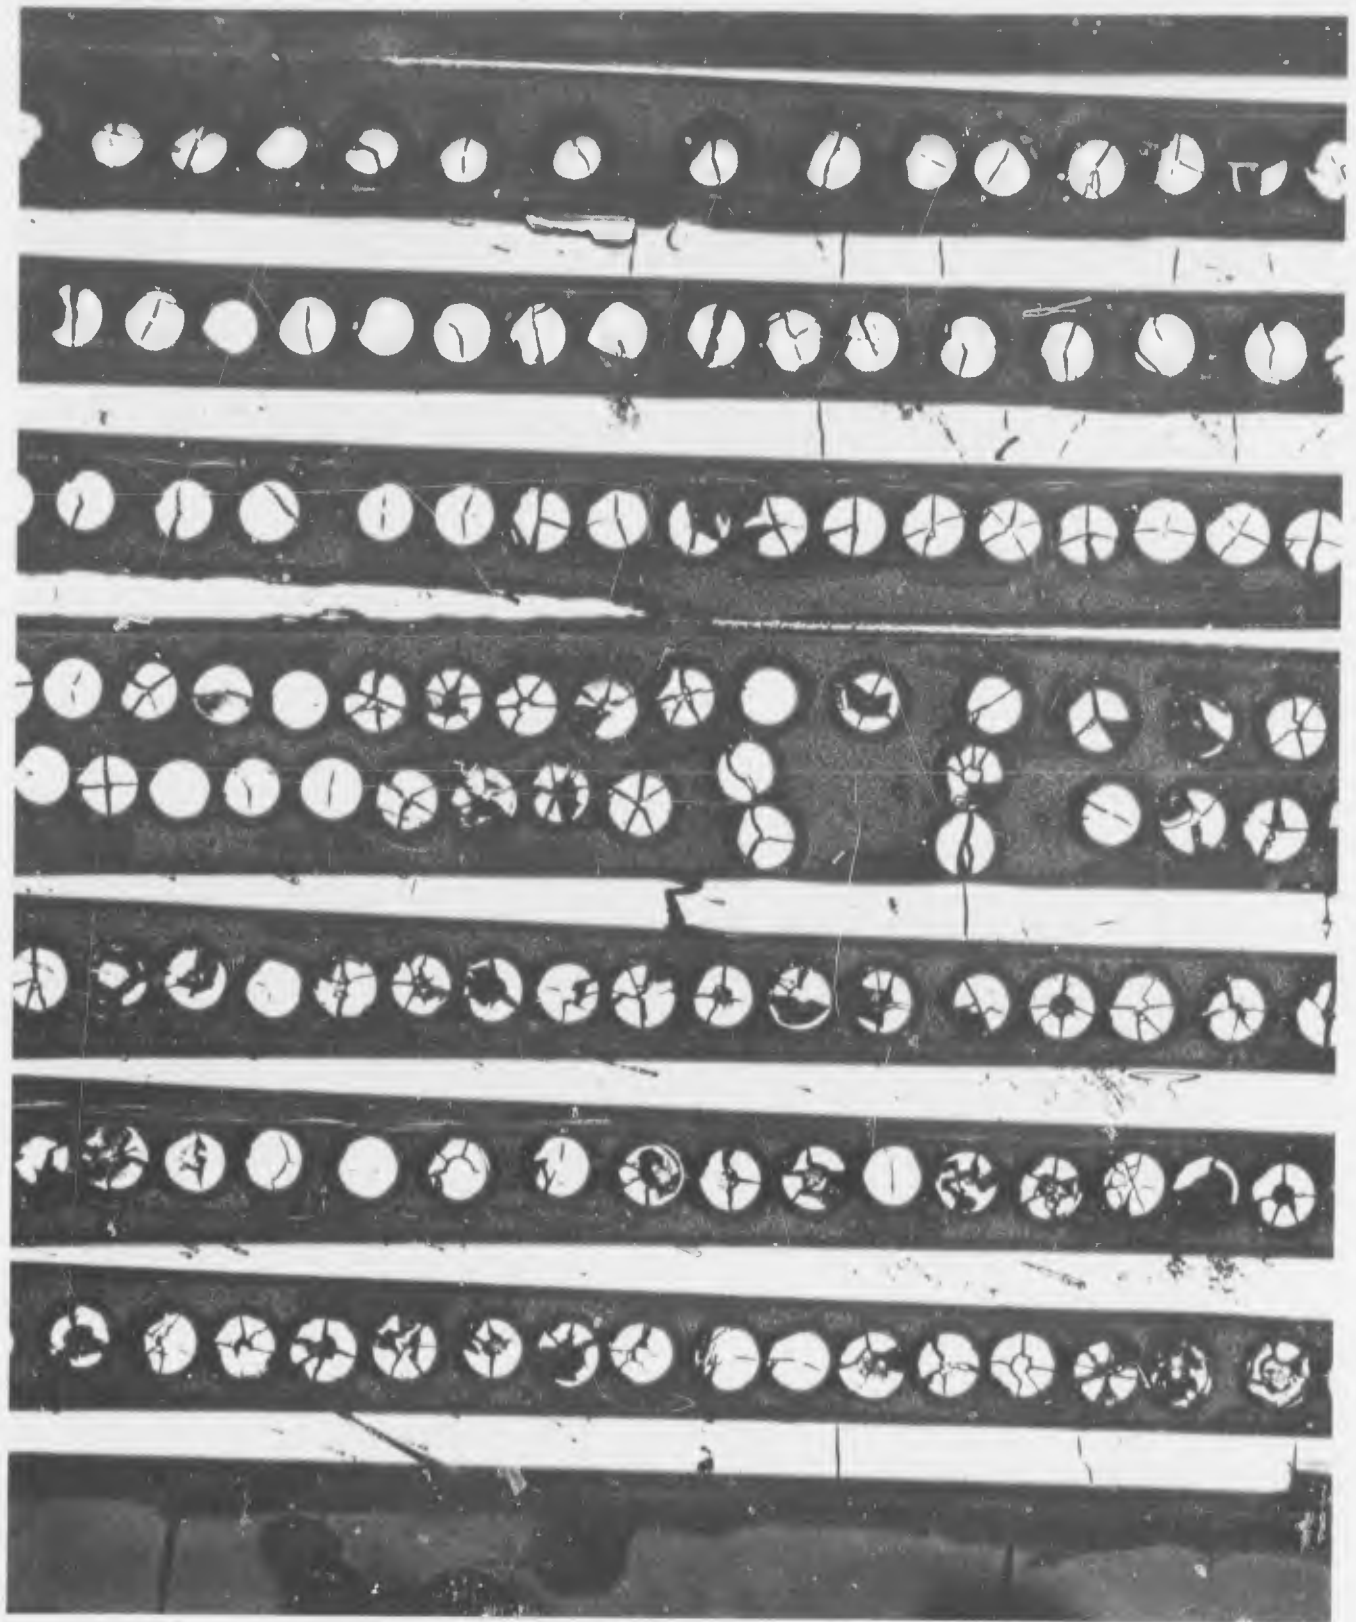
GD-LS-70-3B
(88 kA)

FIGURE 47- 80X Photomicrograph of Tested Panel. Damage Appears Less Severe than Preceding Sample. Star-Shaped Fractures Shown Slightly Past Center

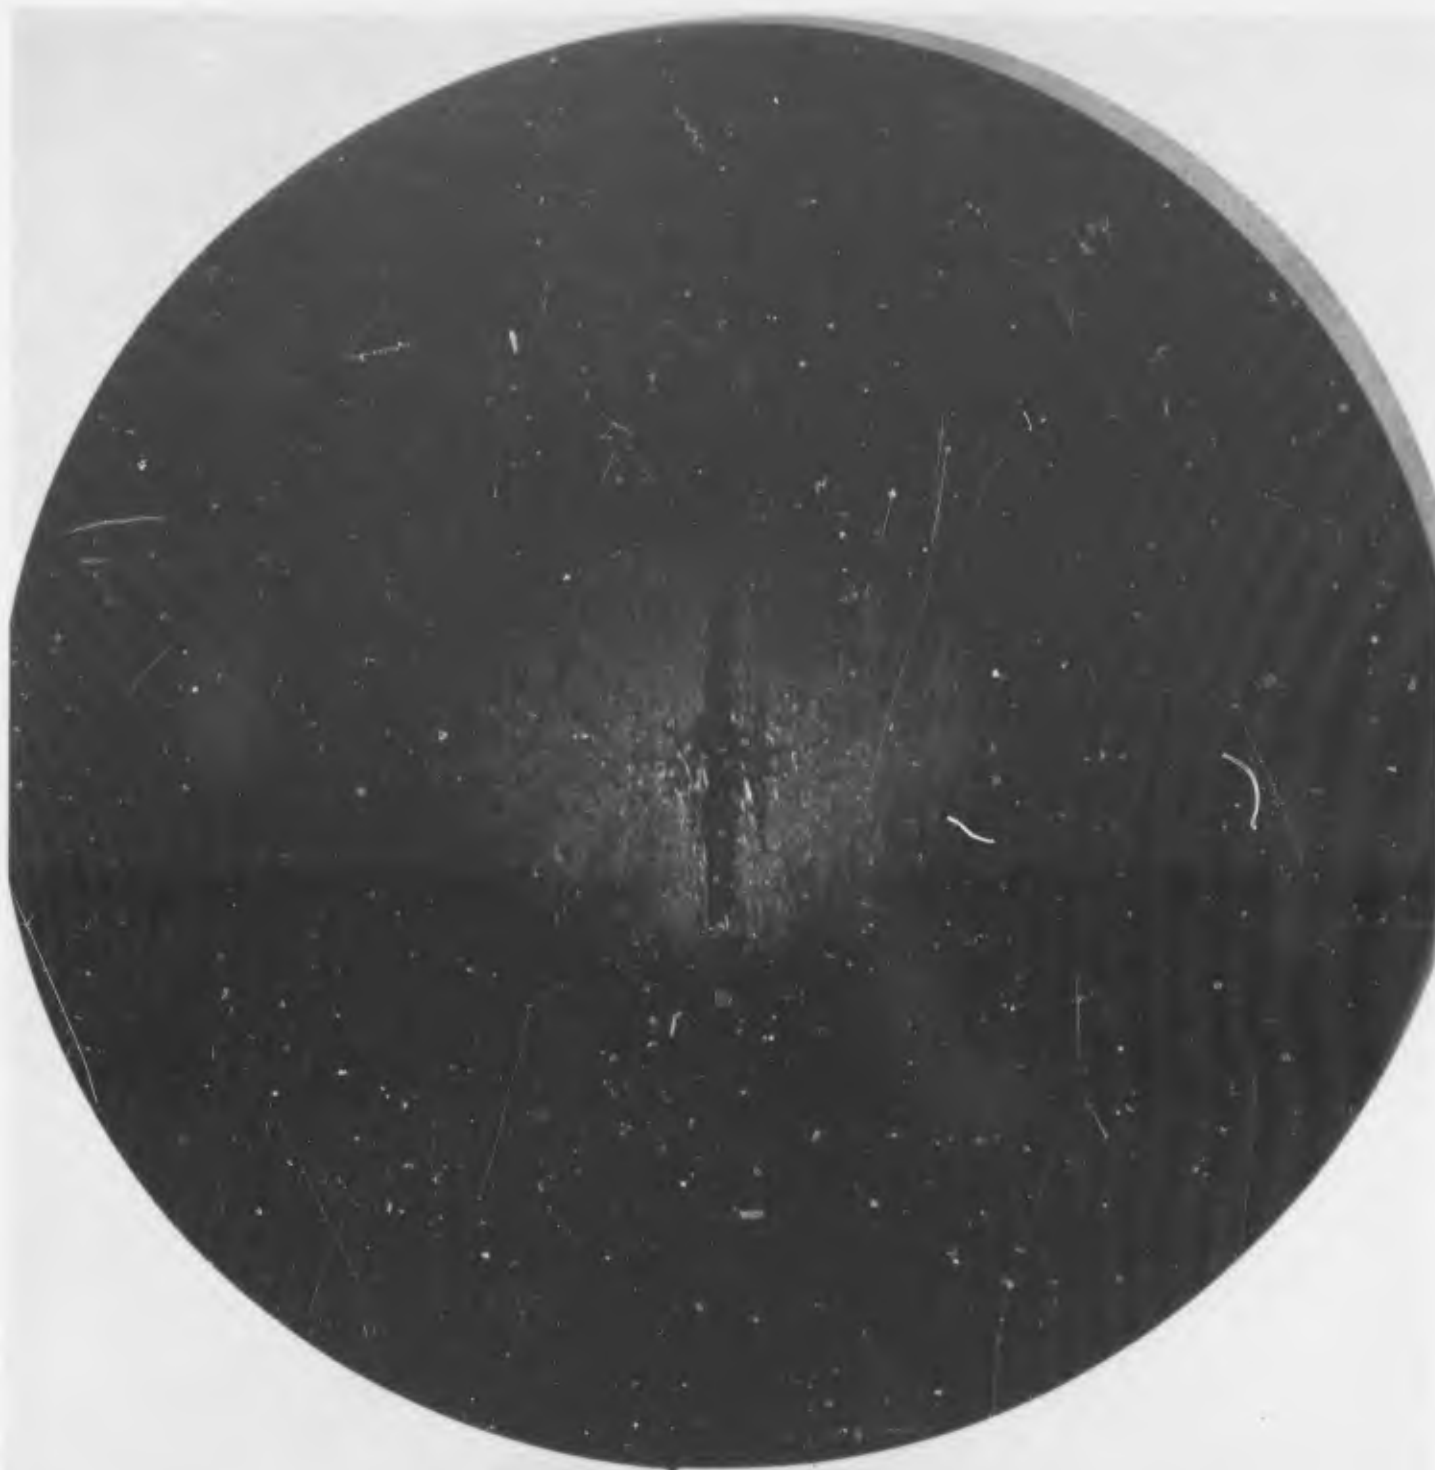
LS-70-2

FIGURE 66 - Damage to Uncoated Graphite Fiber/Epoxy Panel by Simulated Lightning Discharge

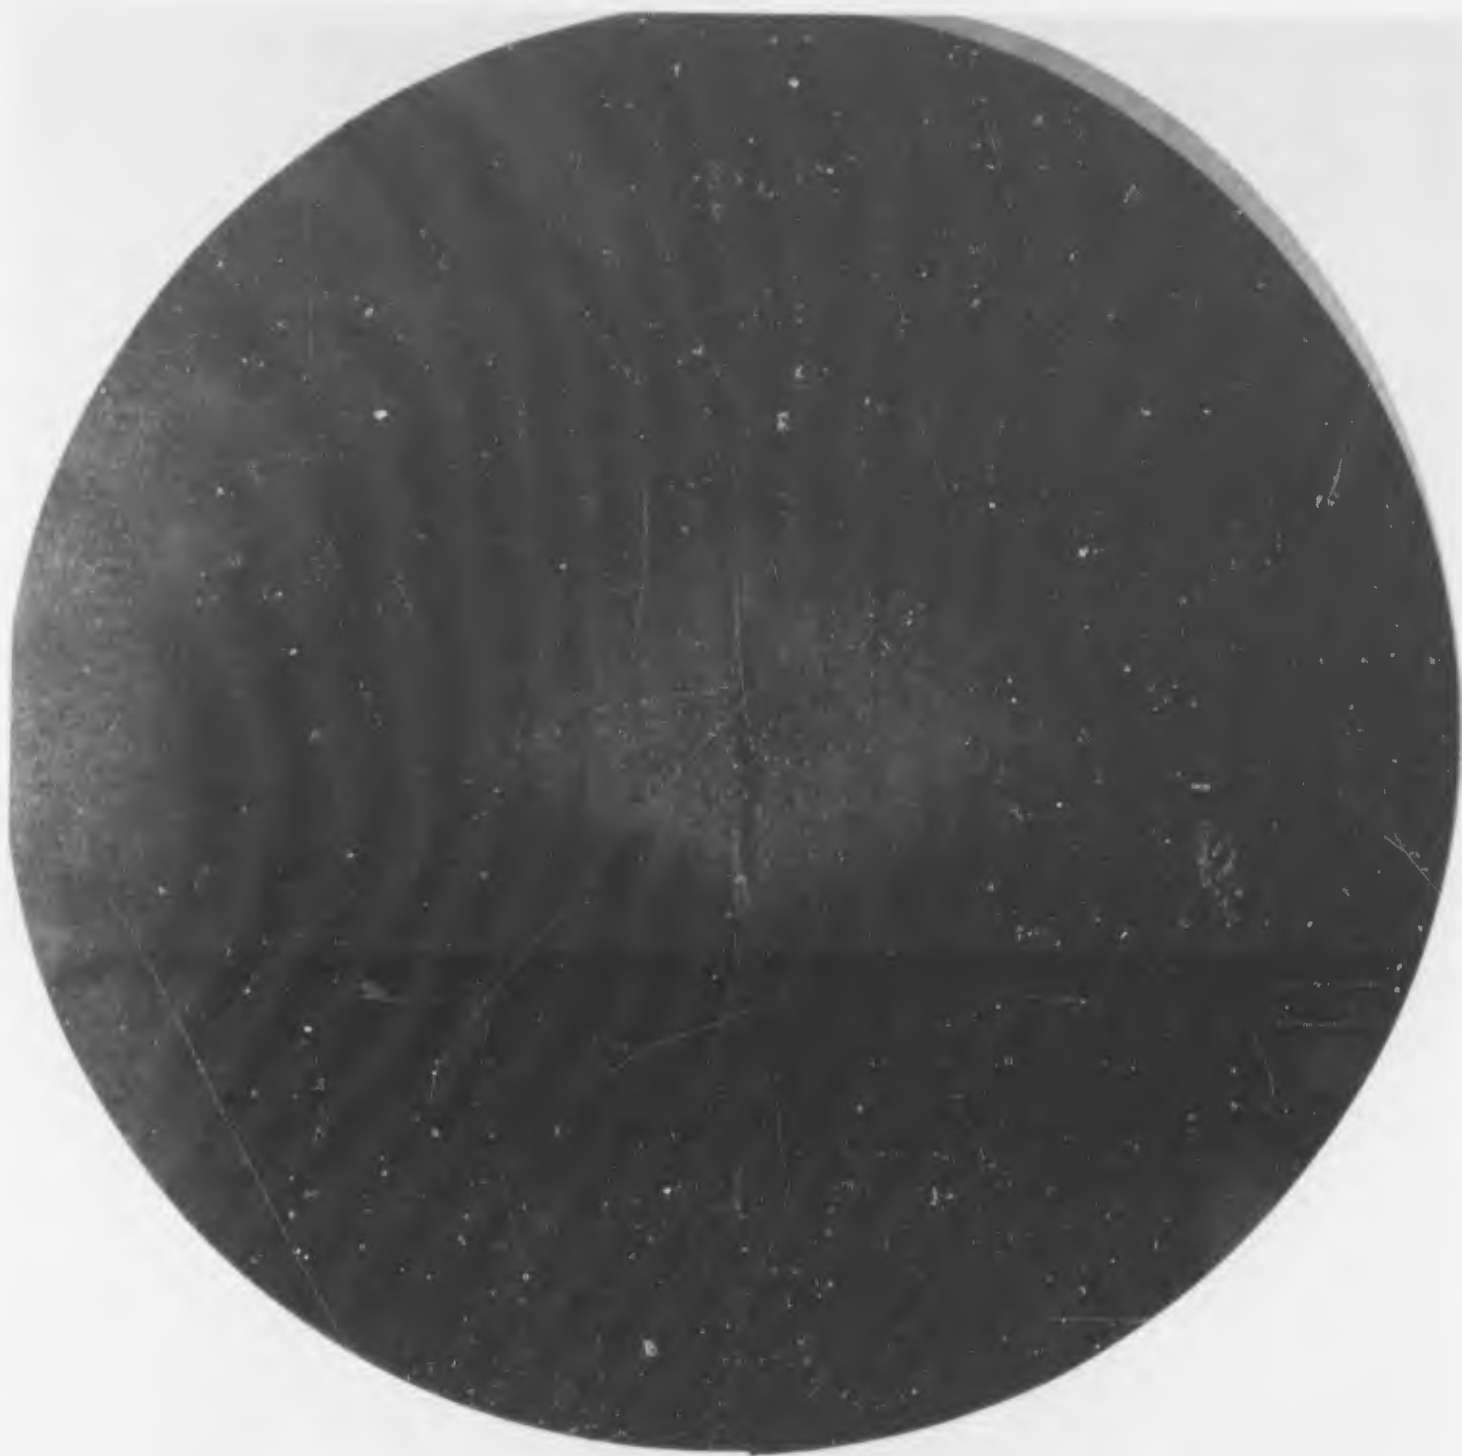
LS-70-3

FIGURE 67 - Damage to Uncoated Graphite Fiber/Epoxy Panel by Simulated Lightning Discharge

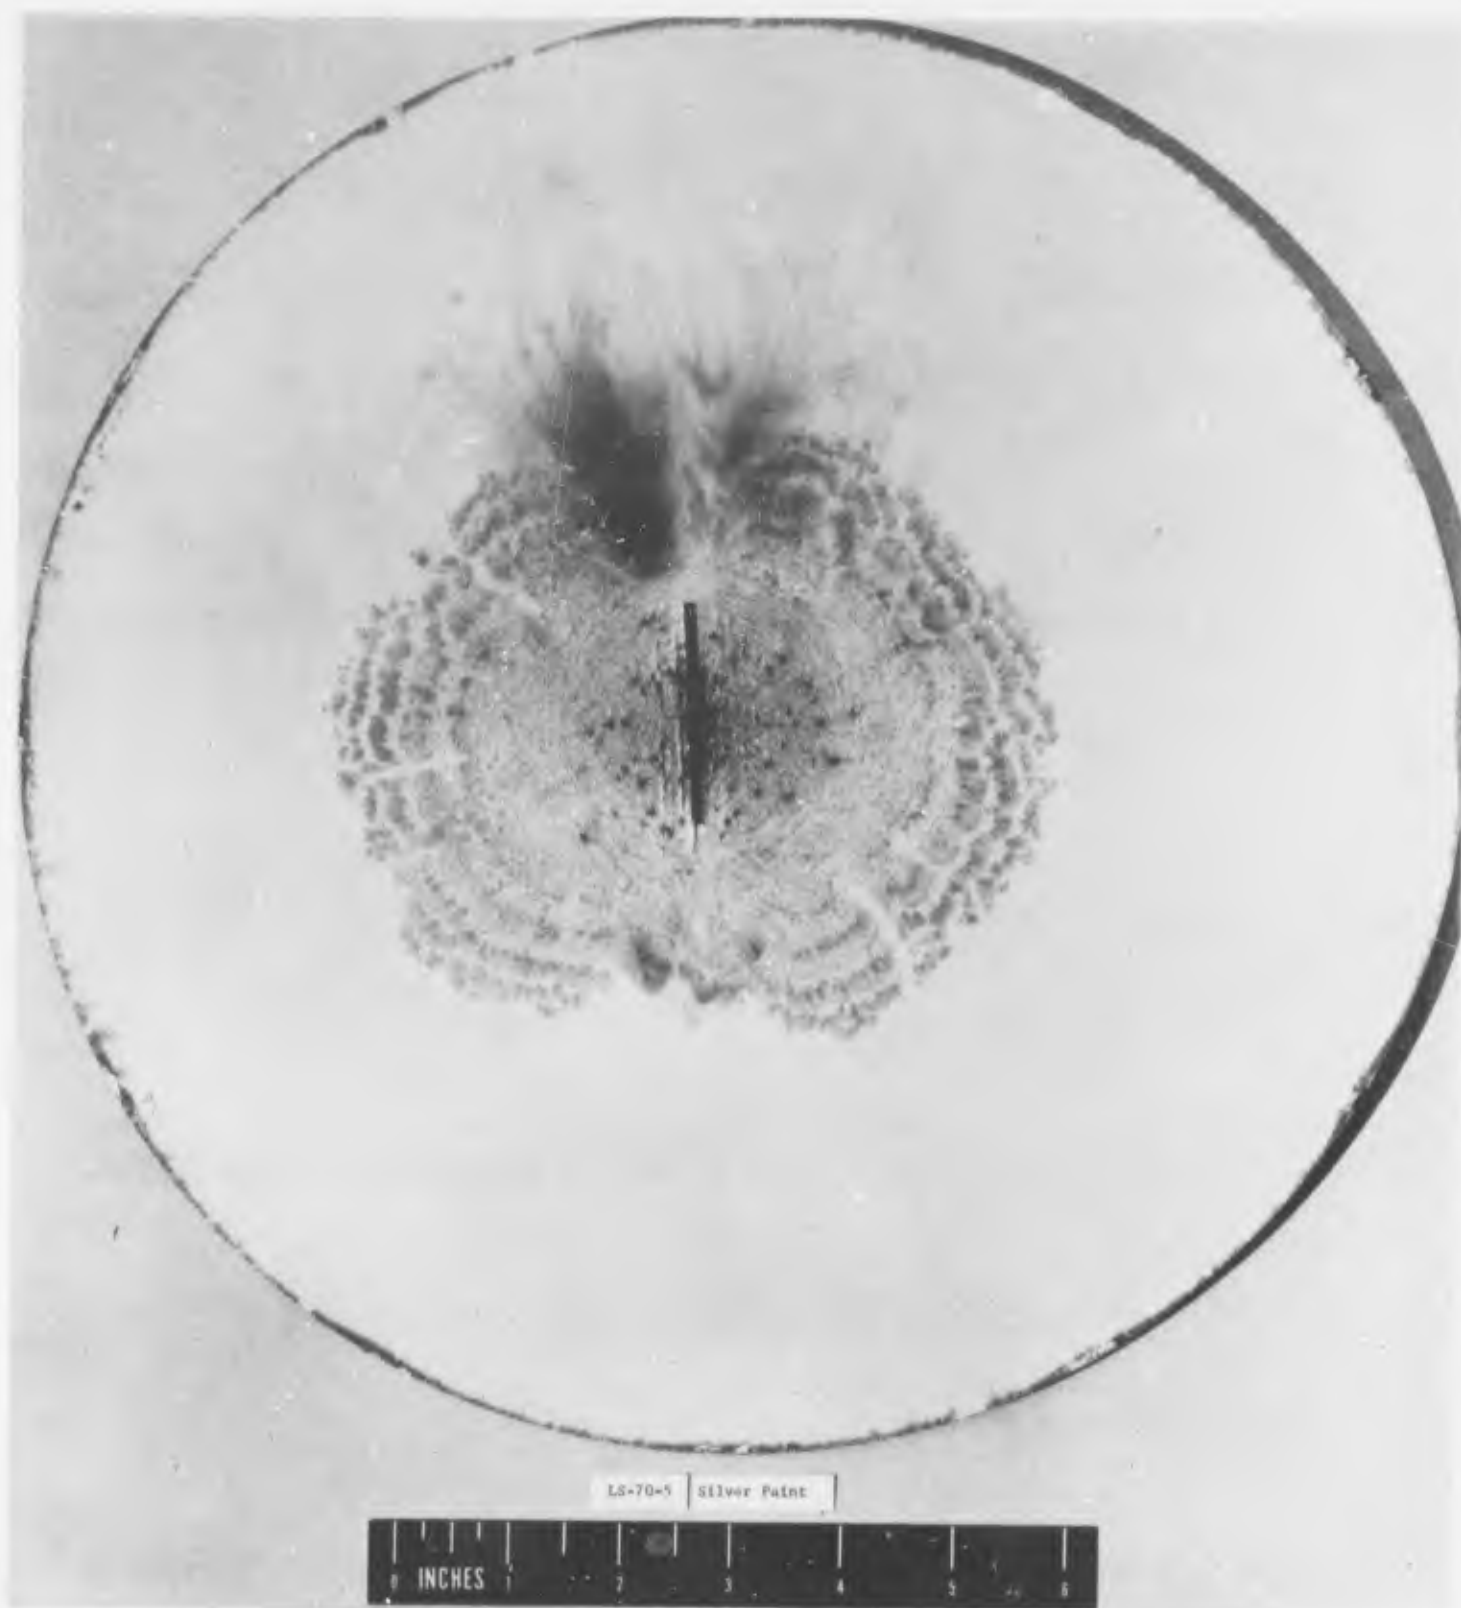
LS-70-5 (Front)
(61 kA)

On the uncoated samples the area of the resin suffering pyrolysis was elliptical or diamond-shaped and apparently caused by resistive heating of the resin by the current flow in the various plies. On the coated sample the area of pyrolysis is circular in shape and shows much less of a ply effect. The area suffering pyrolysis shows a speckled effect around the perimeter of the pyrolyzed area. These speckles are similar to what was observed at the ground-attachment point where the current flowed back out of the graphite material into the ground electrode structure. Possibly what happened was that the current at the stroke-attachment point flowed into the graphite material as the silver-paint coating was blown away, but flowed back out of the panel and into the silver-paint coating as

FIGURE 69 - Damage to Graphite Fiber/Epoxy Panel Coated with Silver Paint, After Exposure to Simulated Lightning Discharge
